**VENETIAN COMMUNITY  
DEVELOPMENT DISTRICT  
RIVER CLUB  
FULL RESERVE STUDY REPORT**

**For 30-Year Projection Period: 2021/2022 to 2051/2052**

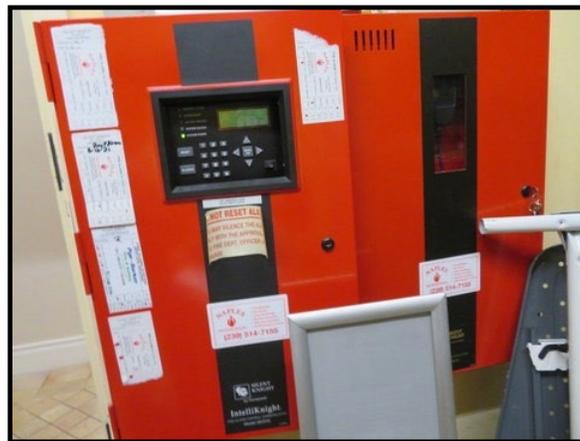
Figure 1 – Control Panel

The River Club maintains a fire alarm system. A fire alarm system comprises a main panel that controls emergency devices such as annunciators and pull boxes. The fire alarm system is original and in good reported condition overall. Changes in building codes and/or technology may make a replacement necessary and/or desirable prior to the useful life of up to 25 years. River Club should budget for replacements by 2030. Annual fire alarm system inspections are required by the National Fire Protection Association (NFPA) 722 Standards. The River Club should fund interim replacement of exit signs and smoke detectors through the operating budget as needed.

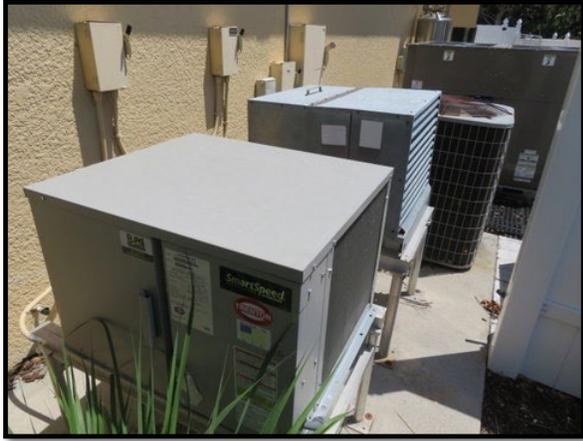
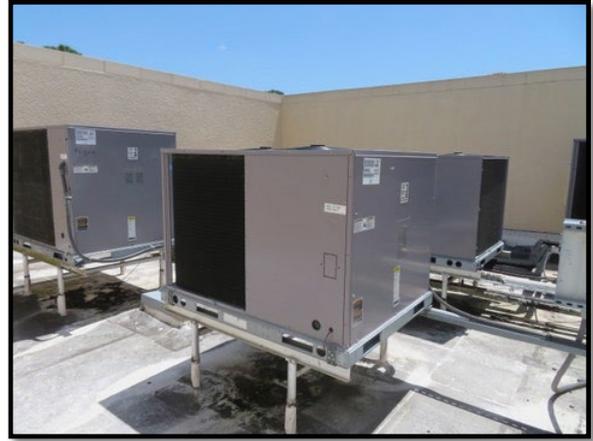
The clubhouse utilizes nine heating, ventilating and air conditioning (HVAC) units. These units were operational at the time of inspection. HVAC units have a useful life from 8- to 12-years. The following table depicts the number of units by tonnage, ages and estimated times and costs of repairs and replacements:

Figure 1 – Ground Units

Figure 2 – Rooftop Units

- The 15-ton inside air handling unit should be relocated to the first floor. This unit has a reheat feature and some of the rooftop units will require a crane to replace which increases the cost per ton.
- The River Club should budget for \$10,000 a year to keep a quarterly maintenance contract in place maximizing the useful life.
- In addition to the existing units, the River Club should budget for installing a makeup air unit over the kitchen in 2021 and replacements every 10 years thereafter.

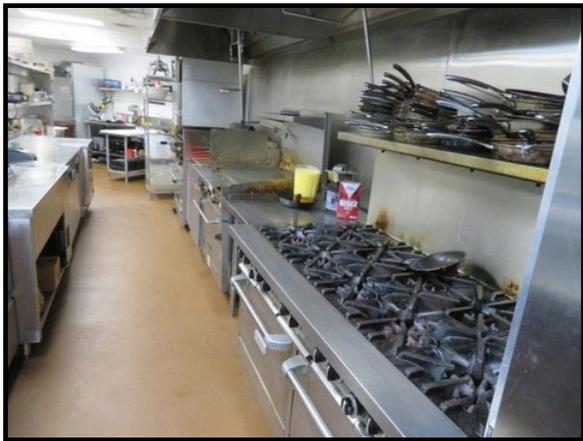
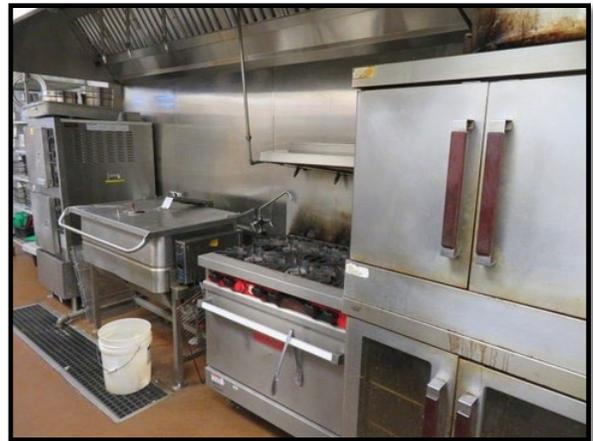
The clubhouse kitchen contains a mixture of food preparation and storage equipment. The useful life of this type of equipment is up to 20 years. Specific discussion of each piece of equipment is beyond the scope of this study. For budgetary purposes, we recommend the River Club budget for replacement of up to twenty-five percent (25%) of the equipment every five years beginning by 2026.

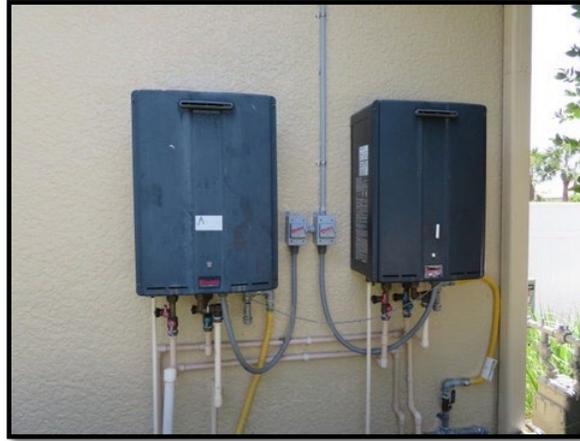
Figure 1

The River Club maintains two tankless gas water heaters that serve the kitchen. These water heaters are in fair condition at an age of approximately six years. Water heaters of this type have a useful life from 10- to 15-years. River Club should budget for replacements by 2027 and every 12 years thereafter. The residential style water heater serving the rest rooms should be funded through the operating budget.

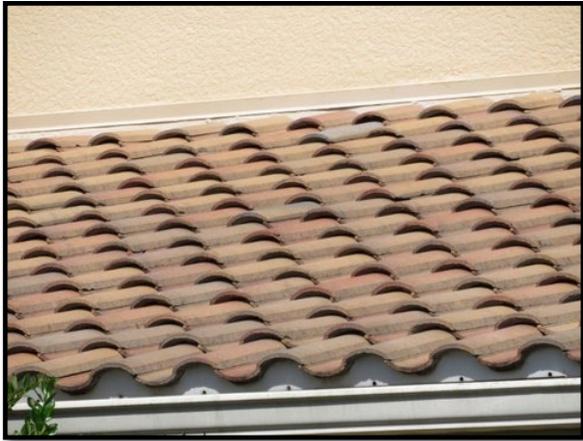
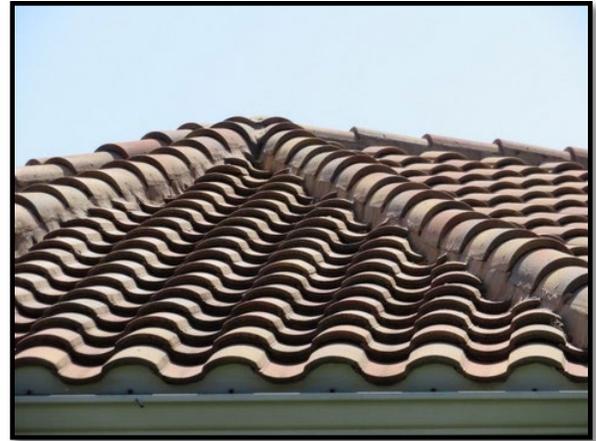
The River Club maintains 227 squares of tile roofing. This quantity includes the tiki bar and tennis building roofs. The roofs are in poor reported condition at an age of 16 years. The useful life of a tile roof of this type is up to 25 years. Manufacturers offer long term warranties as a marketing strategy. A long-term warranty may be of little value if the roof system does not perform satisfactorily and leaks. Conversely, if a roof system is designed, constructed and manufactured well, the expense of purchasing a warranty may not be necessary.

Based on the reported condition, the River Club should budget for replacement of the tile roofs by 2025 and again by 2050. Interim annual inspections are recommended funded through the operating budget.

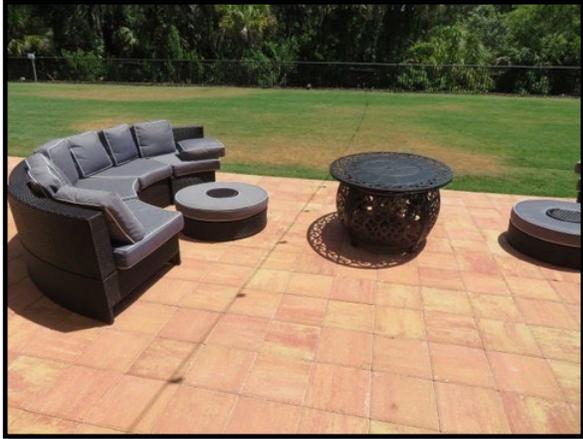
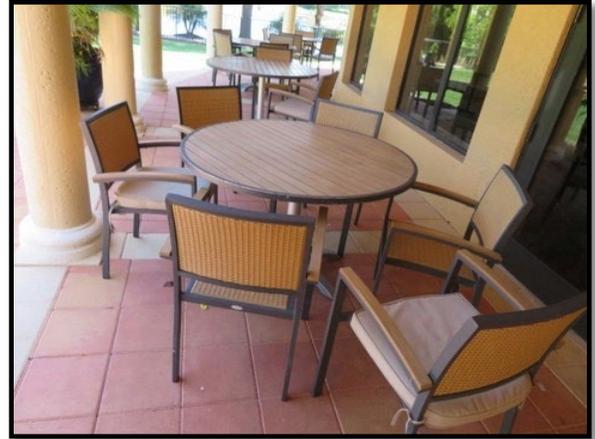
The River Club maintains outdoor furniture for the veranda. This furniture is in fair overall condition at an age of approximately two years. The useful lives of these components vary up to 10 years. However, to maintain aesthetic continuity, River Club should budget for coordinated replacements by 2025 and every 10 years thereafter.

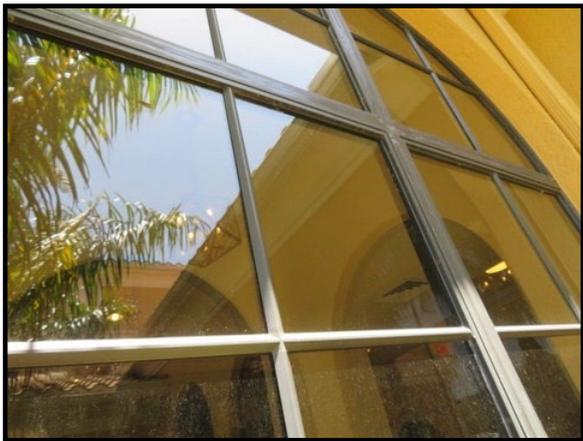
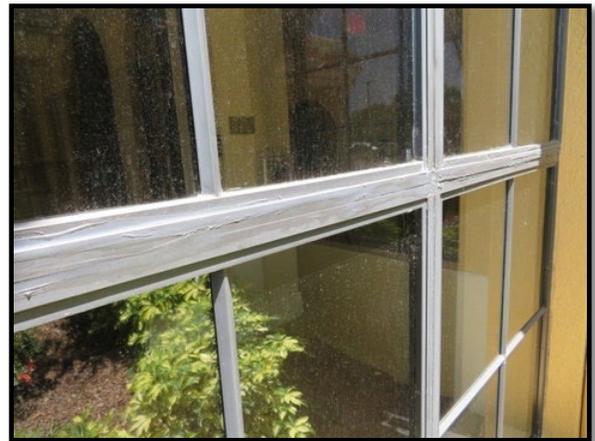
The windows and glass doors of the clubhouse comprise 2,780 square feet. The windows and glass doors are original and in fair overall condition. Windows and glass doors of this type have a long useful life of up to 40 years. The need to replace windows can be due to various reasons such as consistency in style and condition. There will be a cost savings with coordinated replacement. River Club should budget for replacement of the windows and glass doors by 2045.

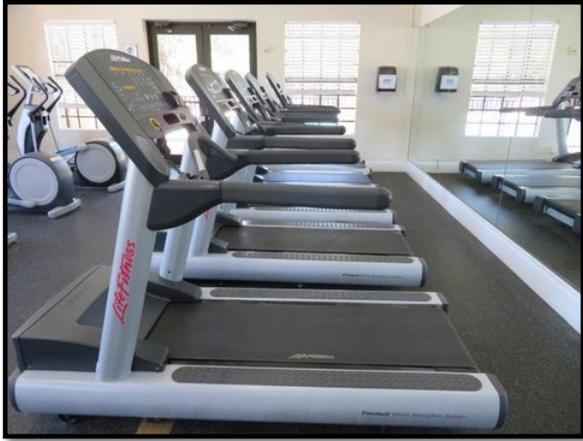
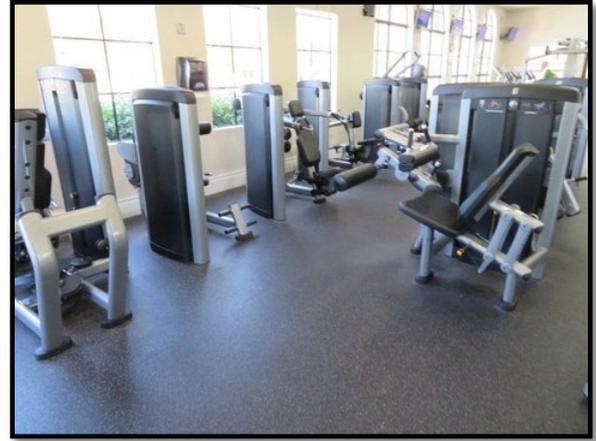
River Club maintains various pieces of strength training and cardio exercise equipment. The exercise equipment is in fair overall condition at various ages. Exercise equipment has a useful life of up to 10 years. The River Club should budget for phased replacement of up to fifty percent (50%) of the cardiovascular equipment by 2023 and every three years thereafter. The River Club should budget for all the strength training equipment every 10 years beginning by 2027.

Figure 1 – Cardiovascular Equipment

Figure 2 – Strength Training Equipment

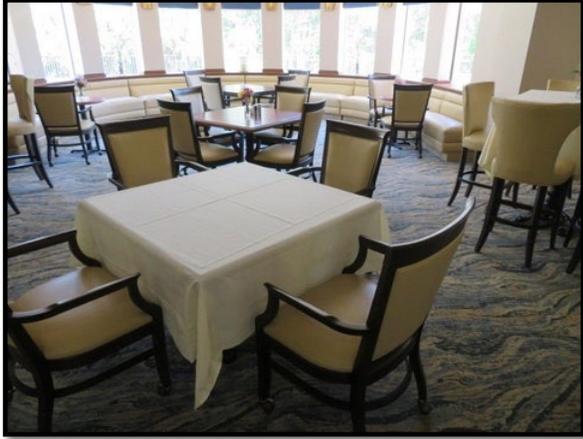
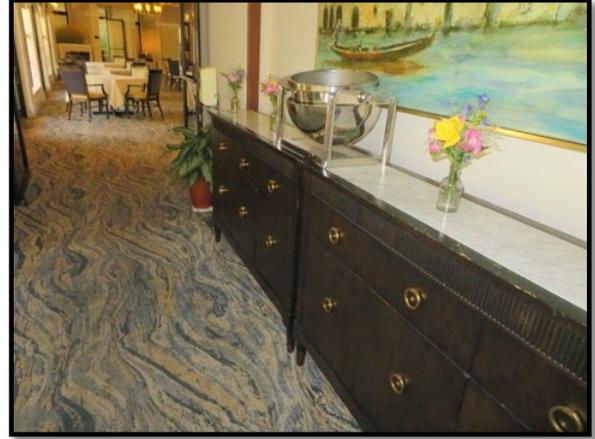
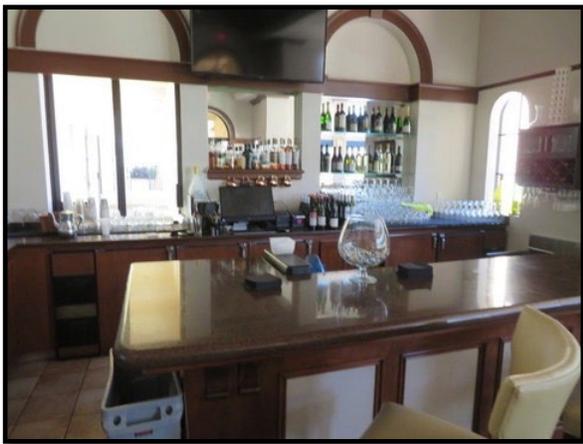
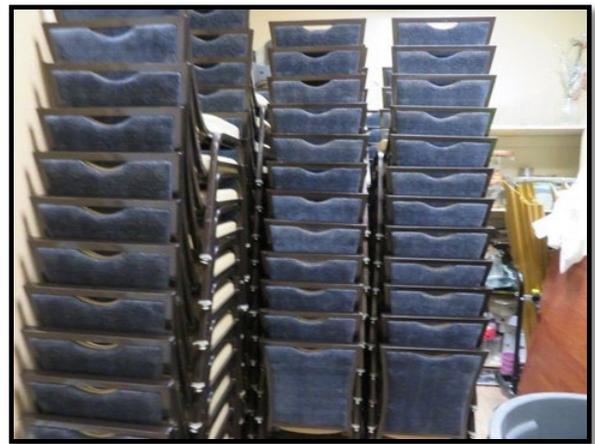
The River Club maintains various furniture components. The furniture is in fair to good overall condition at an age of approximately five years. The useful lives of these components vary from 10- to 15-years. However, to maintain aesthetic continuity, River Club should budget for coordinated replacements by 2029 and every 12 years thereafter.

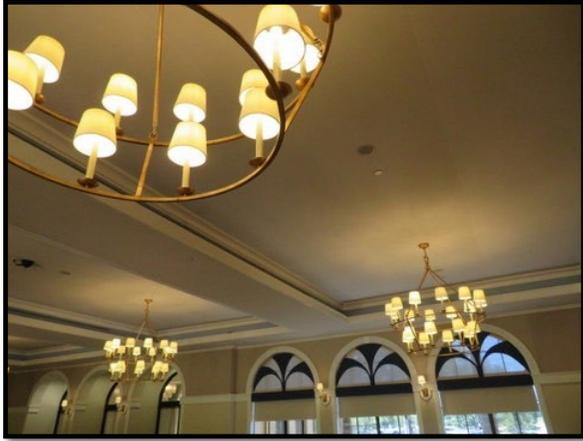
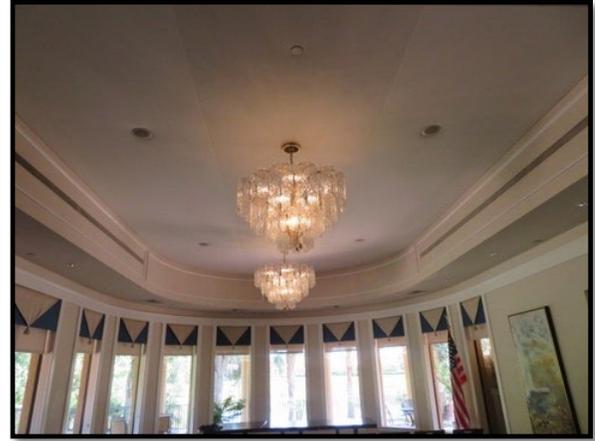
The River Club maintains interior ceiling and wall mounted light fixtures. The lighting is in good condition at an age of five years. Light fixtures of this type have a useful life from 15- to 20-years. River Club should budget for replacements by 2029. River Club should fund replacement of recessed lights through the operating budget.

Figure 1 – Dining Room Lighting

Figure 2 – Lounge Lighting

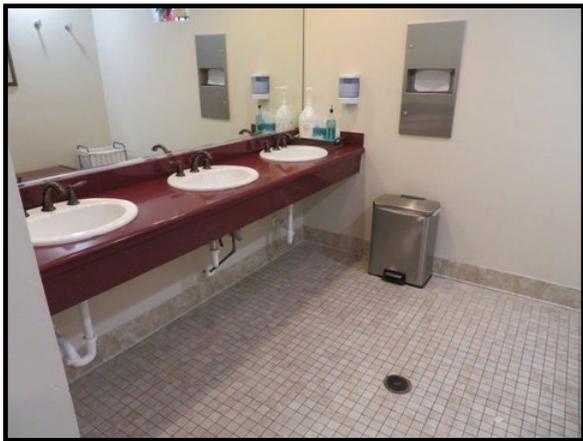
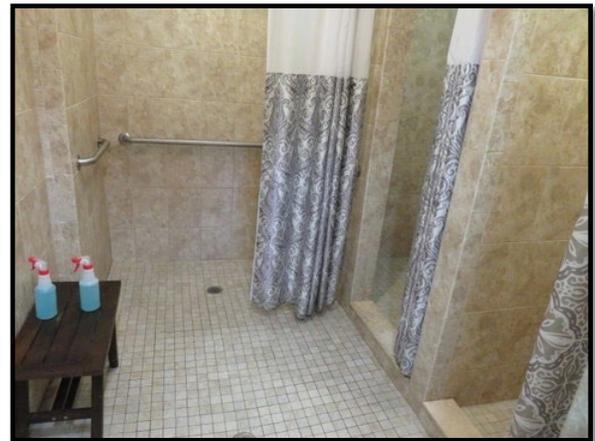
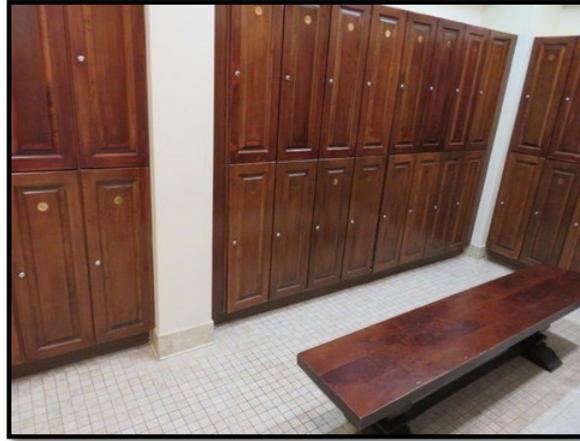
The River Club maintains a men’s and women’s locker room. The locker rooms comprise furnishings, plumbing and electrical fixtures, tile wall and floor coverings. The locker rooms are in fair overall condition at an age of approximately 10 years. These locker room components have a useful life of up to 15 years. River Club should budget for renovations of the locker rooms by 2025 and every 12 years thereafter.

Figure 1 – Men’s Locker Room Sinks

Figure 2 - Men’s Locker Room Showers

Figure 3 – Men's Locker Room Lockers

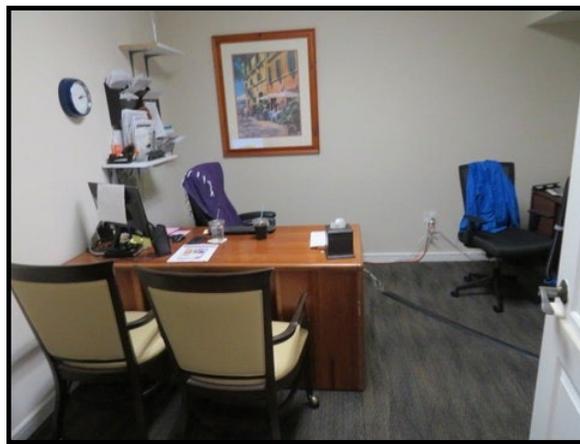
Figure 1

The River Club maintains several offices. The office equipment and furniture is in fair condition. The exact ages are unknown. We include an allowance to replace office equipment and furniture by 2025 and every five years thereafter in conjunction with carpet replacements every other cycle.

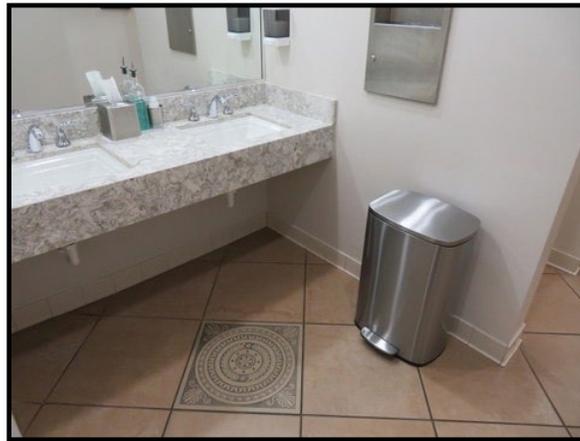
The River Club is responsible for two main rest rooms in addition to the ones located in the locker rooms. The rest rooms comprise plumbing and electrical fixtures, tile wall and floor coverings. These rest room components are in good overall condition at an age of five years. These rest room components have a useful life from 10- to 15-years. River Club should budget for renovations of the rest rooms by 2029 and again by 2041. The River Club should fund renovations of the kitchen rest room through the operating budget.

Figure 1 – Men's Rest Room

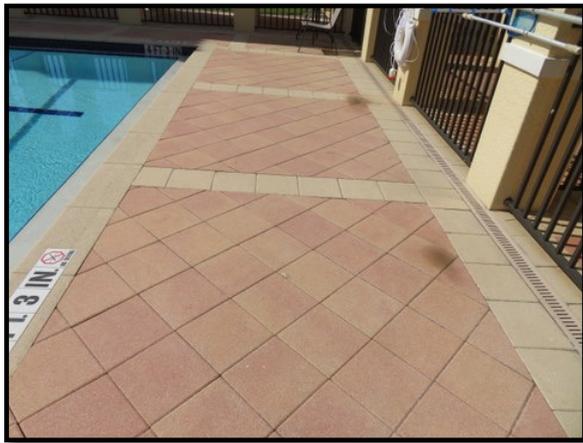
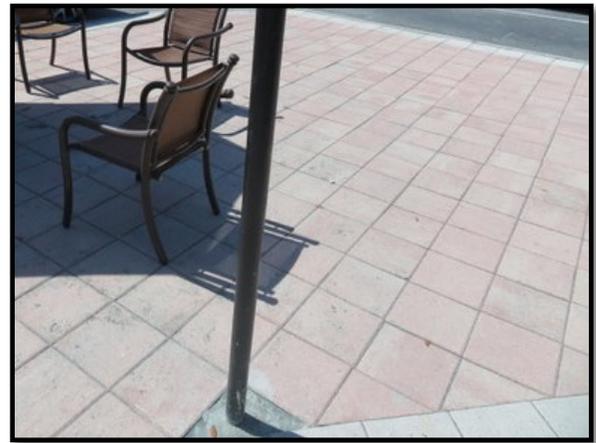
The pool deck comprises approximately 17,800 square feet of pavers. This quantity includes the walkway pavers around the tennis courts. These pavers are mostly original and in fair to good overall condition. Pool deck pavers have a useful life from 20- to 30-years with the benefit of periodic maintenance. Periodic maintenance includes resetting as needed and an application of sand between the pavers followed by a sealer application every four years beginning in 2022. The wash and seal quantity includes the vehicular pavers. The River Club should budget for replacement of the pavers by 2030. Interim repairs should be funded through the operating budget as needed.

Figure 1 – Pool Deck Pavers

Figure 2 – Tennis Court Sitting Area

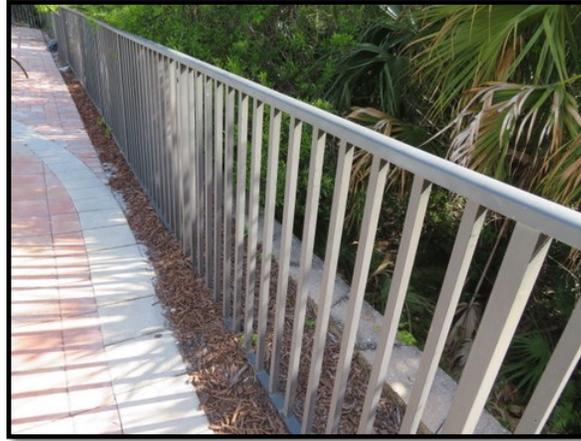
Figure 1

Approximately 750 linear feet of aluminum fence surrounds the pool area. This fence is in fair condition overall at an age of 17 years. There are reported issues with the gates and areas near the back are dragging on the pavers. The finish on aluminum fences is relatively maintenance free. Aluminum fences have a useful life of up to 20 years. River Club should budget for replacement by 2025 and again by 2045. Minor interim repairs should be funded through the operating budget.

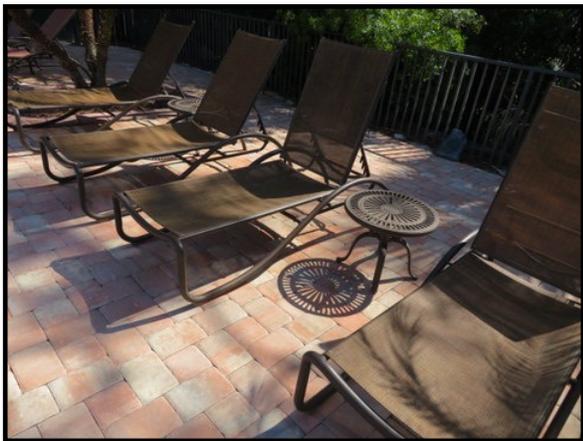
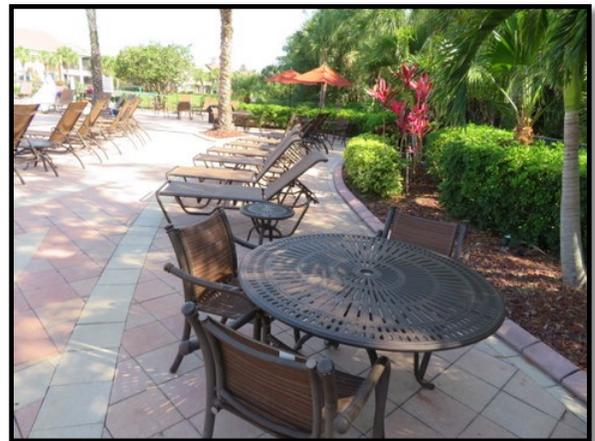
The pool furniture includes umbrellas, lounges, tables and chairs. The pool furniture is in fair condition overall at various ages. Management and the Board report that the River Club plans to add furniture in the near term. The pool furniture has a useful life from 5- to 10-years. The River Club should budget for partial replacements beginning in 2022 and every five years thereafter.

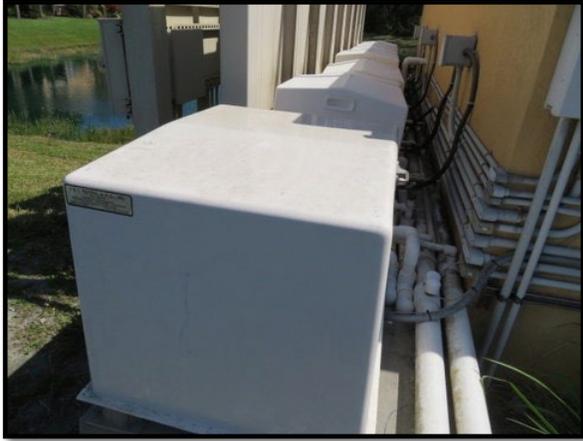
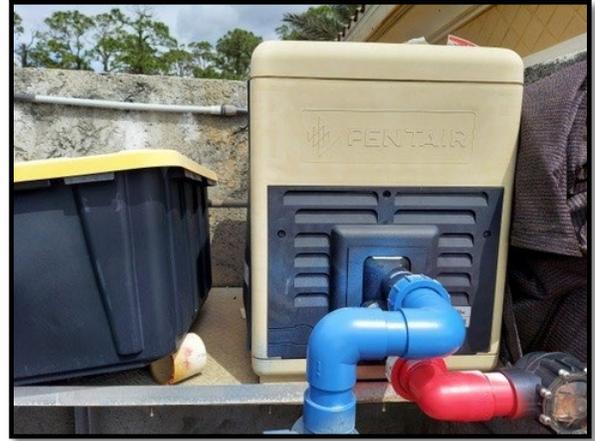
River Club maintains a geothermal pool heating system along with pool and spa booster heaters. This heating system is in fair overall condition at various ages. This pool heating system has a useful life of up to 15 years. River Club should budget for phased replacements beginning by 2024 and every five years thereafter.

Figure 1 – Geothermal Heaters

Figure 2 – Typical Heater

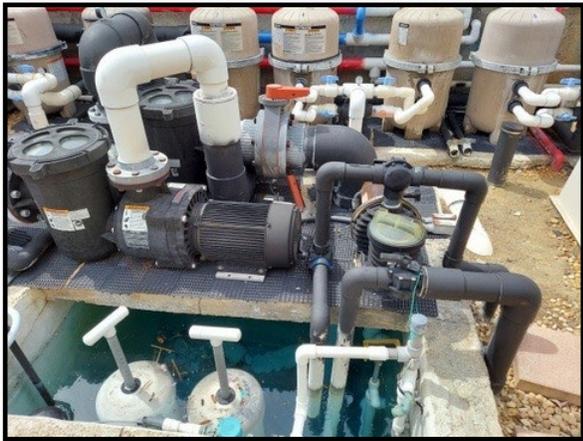
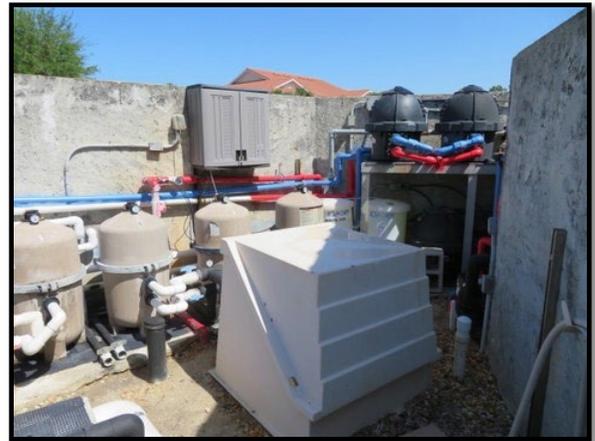
River Club maintains pool and spa mechanical equipment includes pumps, filters and chlorinators. The mechanical equipment is in fair overall condition at various ages. River Club should budget for phased replacements by 2026 and every five years thereafter.

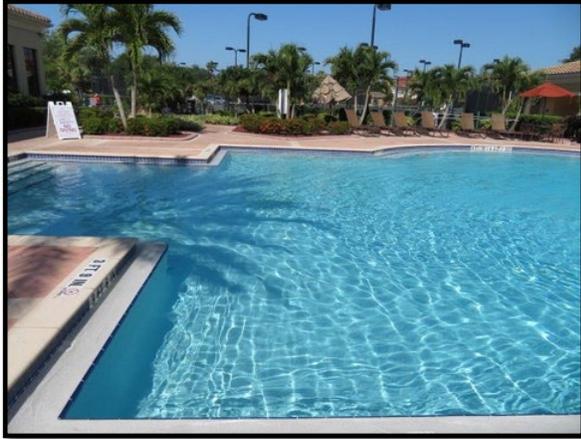
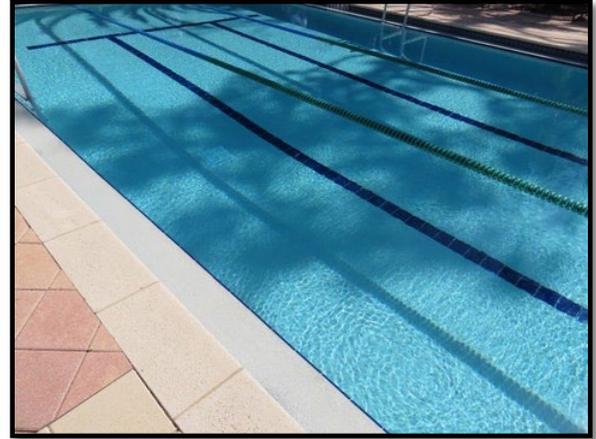
allowance for replacement of the waterline tile is included in the estimate of cost. Potential repairs to the underlying pool structure may raise the estimate of cost.

Figure 1 – Main Pool

Figure 2 – Lap Pool

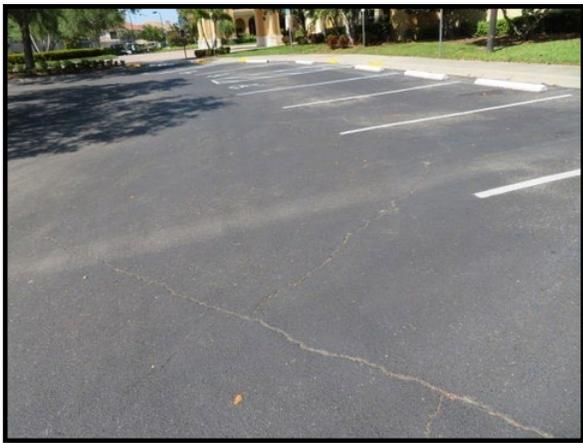
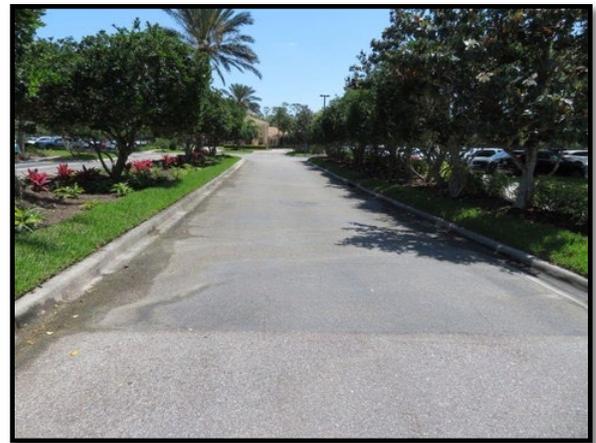
The River Club maintains approximately 9,060 square yards of asphalt parking area. The asphalt pavement is original and in fair overall condition. Asphalt pavement comprises multiple layers. Typically the top layer or surface course deteriorates over time and can be milled or removed and overlaid or replaced. The following diagram depicts typical pavement layers.

The asphalt coating has a useful life of five- to eight-years. River Club should plan for an application of pavement preservation in 2023. This first application can continue with seal coating until after repaving occurs. Then, subsequent cycles of rejuvenation are recommended every five - to eight-years thereafter.

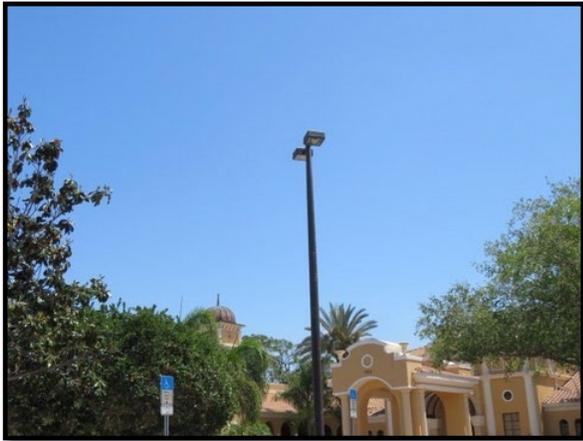
The River Club maintains nine light poles and fixtures located around the parking areas. These light poles and fixtures are in fair condition at an age of 17 years. A broken light fixture is depicted in the following picture. Light poles have a useful life of up to 25 years. River Club should budget for replacements by 2030. Interim fixtures should be funded through the operating budget as needed. The River Club should also fund replacement of the three solar light poles and fixtures through the operating budget.

Figure 1 – Light Pole and Fixtures

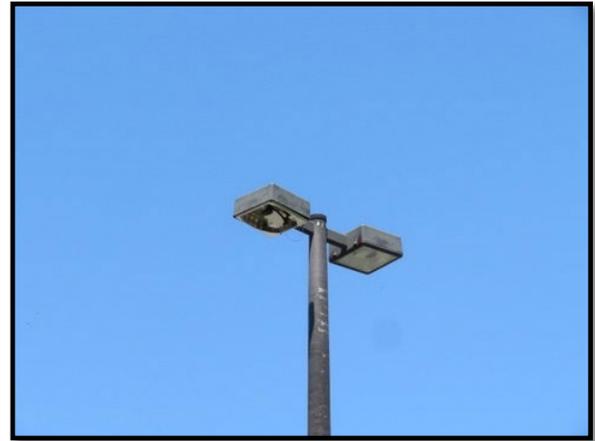
Figure 2 – Broken Light Fixture

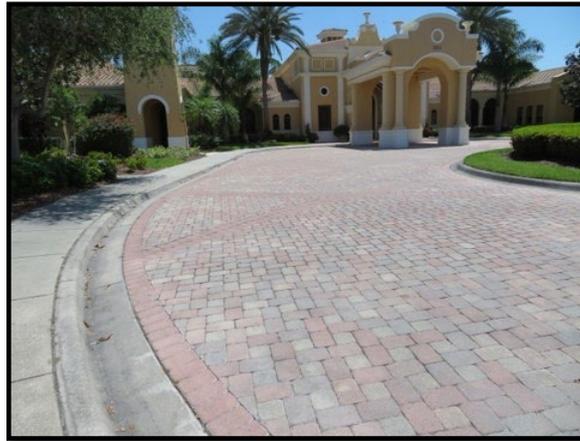
The River Club rotary pavers comprise approximately 8,275 square feet of vehicular pavers. Vehicle pavers have a useful life from 15- to 25-years with the benefit of ongoing maintenance that includes pressure washing, an application of sand between the pavers and resetting as needed followed by sealer applications every three- to five-years. The River Club should budget for this maintenance activity through the operating budget and fund for replacements by 2028.

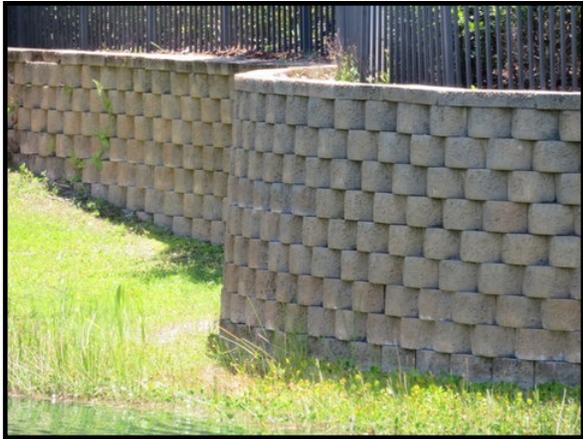
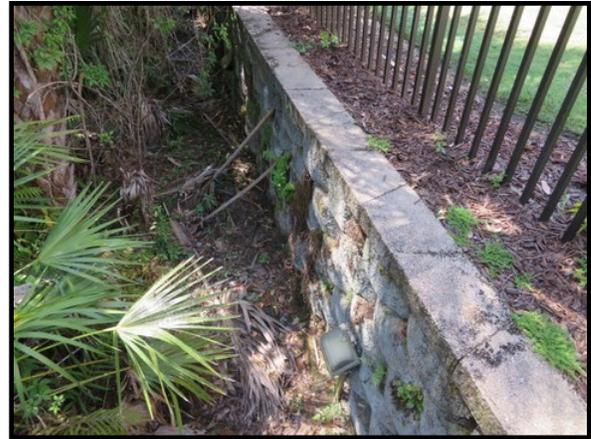
The River Club maintains approximately 3,000 square feet of concrete masonry unit (CMU) segmental retaining walls. Retaining walls provide lateral support to vertical slopes of soil. The retaining walls are original and in good condition overall. Weep holes were not evident. Weep holes

allow water to drain from behind the wall alleviating pressure. Water is the leading cause of wall failures. Segmental walls are dry stacked which allow water to drain. However, this type of drainage is not always adequate and should not be relied upon. Retaining walls of this type have a long useful life. Poor design or construction poses serious safety hazards. Total collapses are relatively rare and most issues can be repaired. River Club should budget for partial replacements of up to sixty-five percent (65%) by 2051 and vegetation control through the operating budget.

Figure 1 – Retaining Wall Overview

Figure 2 - Vegetation Control Needed

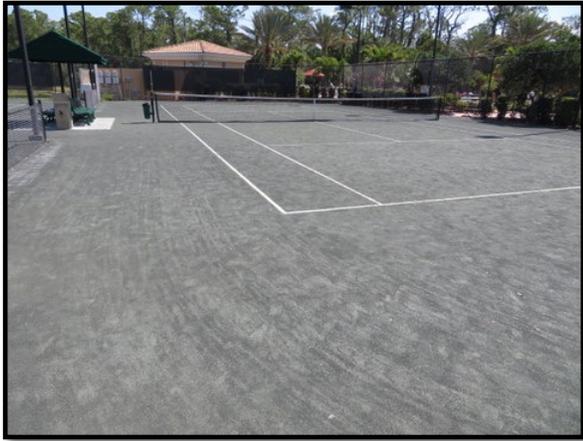
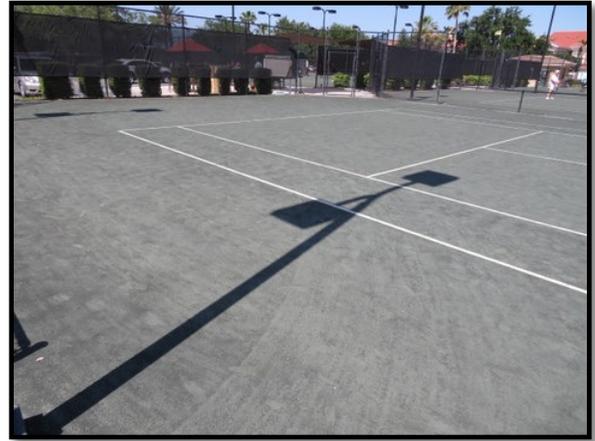
replacements are likely beginning by 2046 and concluding by 2047. The courts also require scarifying, replenishments, and laser leveling every eight years. River Club should budget for this maintenance activity by 2030 and every eight years thereafter.

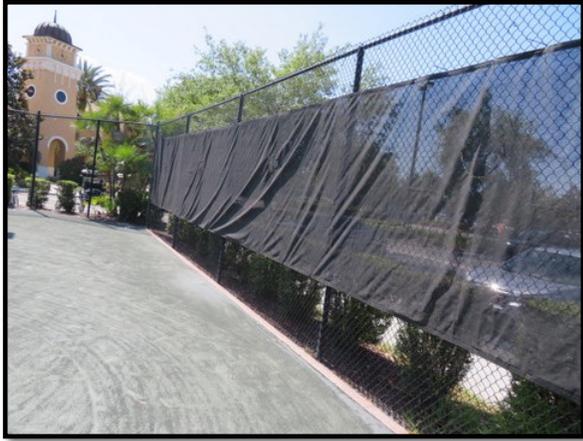
The 1,360 linear feet of fence that surrounds the tennis court is in good condition at an age of less than one year. The fence has a useful life of up to 20 years. River Club should budget for replacements by 2041.

Figure 1 – Tennis Fence
